3M Corrosion Protection Products

# UV Protection of Line Coated Pipe

NAPCA Workshop – 8/20/09

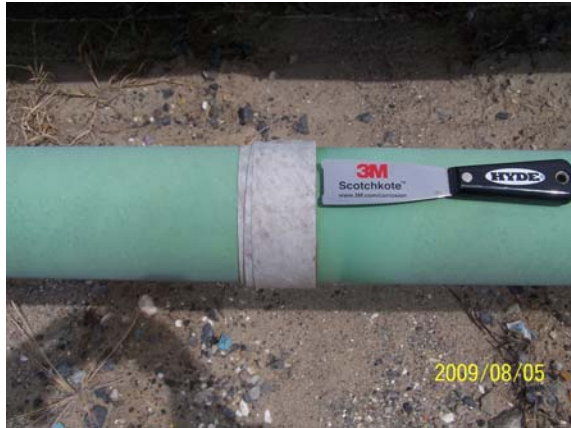
Cardboard protector

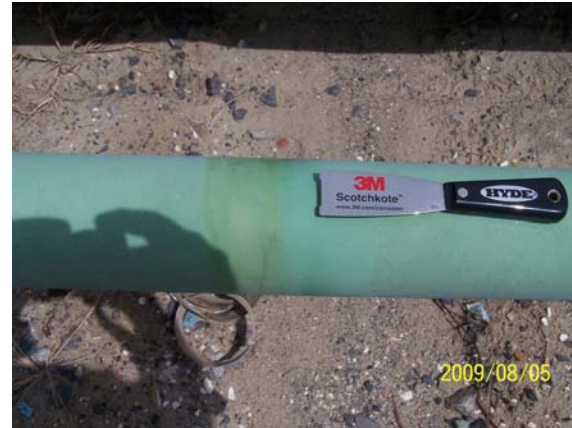
Cardboard protector removed

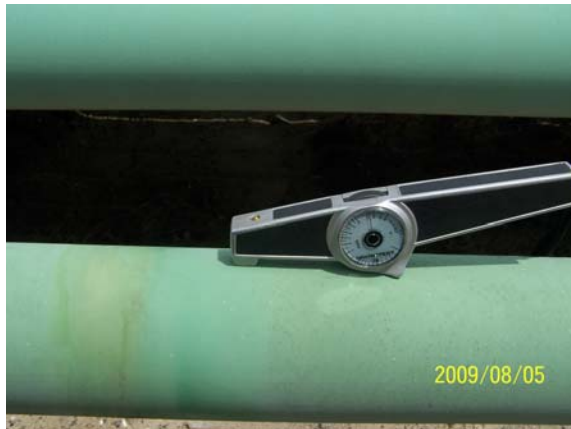
Thickness of UV Exposed Area (16.5 mils)

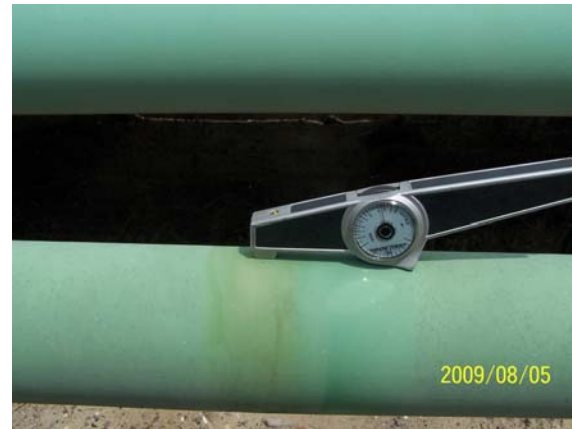
Thickness of UV Protected Area (17.5 mils)

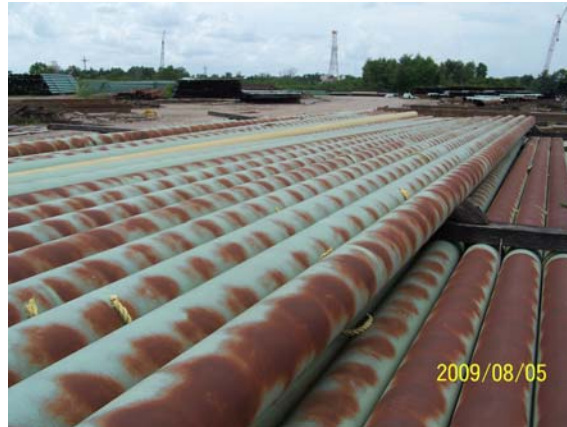
Exposure Overview

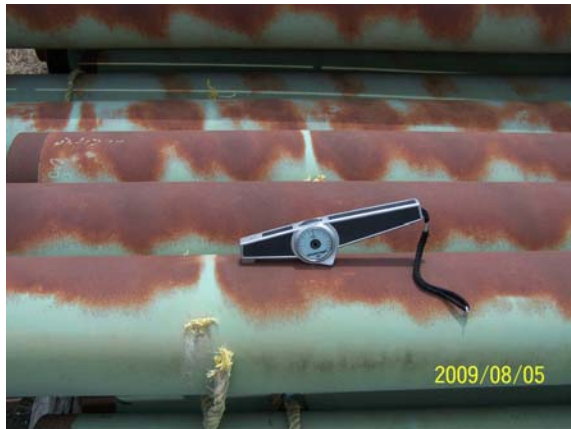
Thickness of UV Exposed Area (3.7 mils)

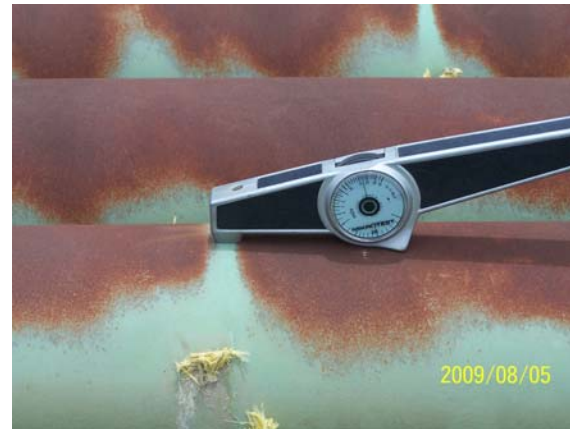
Thickness of UV Protected Area (17 mils)
